14
15 The purpose of the Prudential buildings evaluation was to review actions taken to date by
16 the building owner, conduct inspections of remaining fireproofing in the buildings,
17 determine the current condition of the remaining asbestos-containing fireproofing, conduct
18 sampling as appropriate, and opine on the reasonableness of the asbestos program
19 implemented by the building owner.

3 The Brookhollow I building is a 12-story office building located in Houston, TX. The
4 building was reported to have approximately 175,000 ft² of friable fireproofing applied to
5 all the structural steel of the building.⁽³³⁾ The fireproofing was reported to have been
6 completely removed. The reason for the removal and replacement of the fireproofing was
7 reported by Mr. O. Dean Holcomb (Property Manager) was to facilitate complete
8 renovation of the space for the new tenant (Harris County Appraisal District).

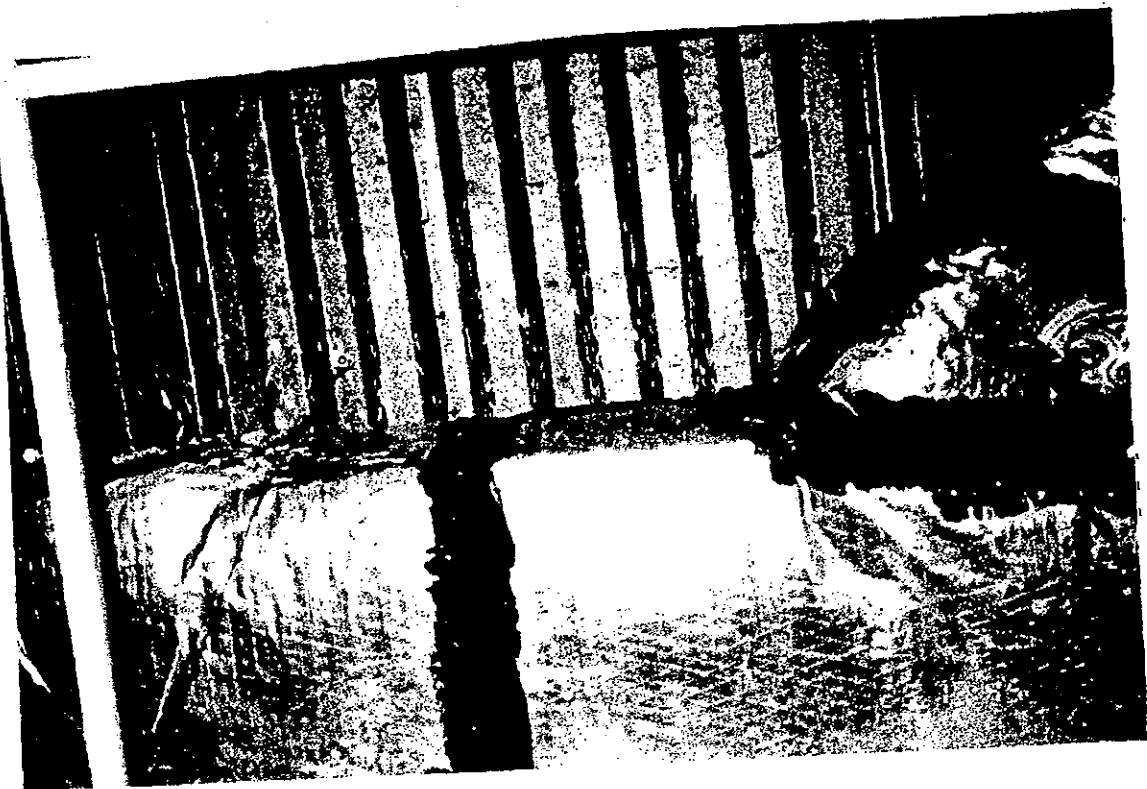
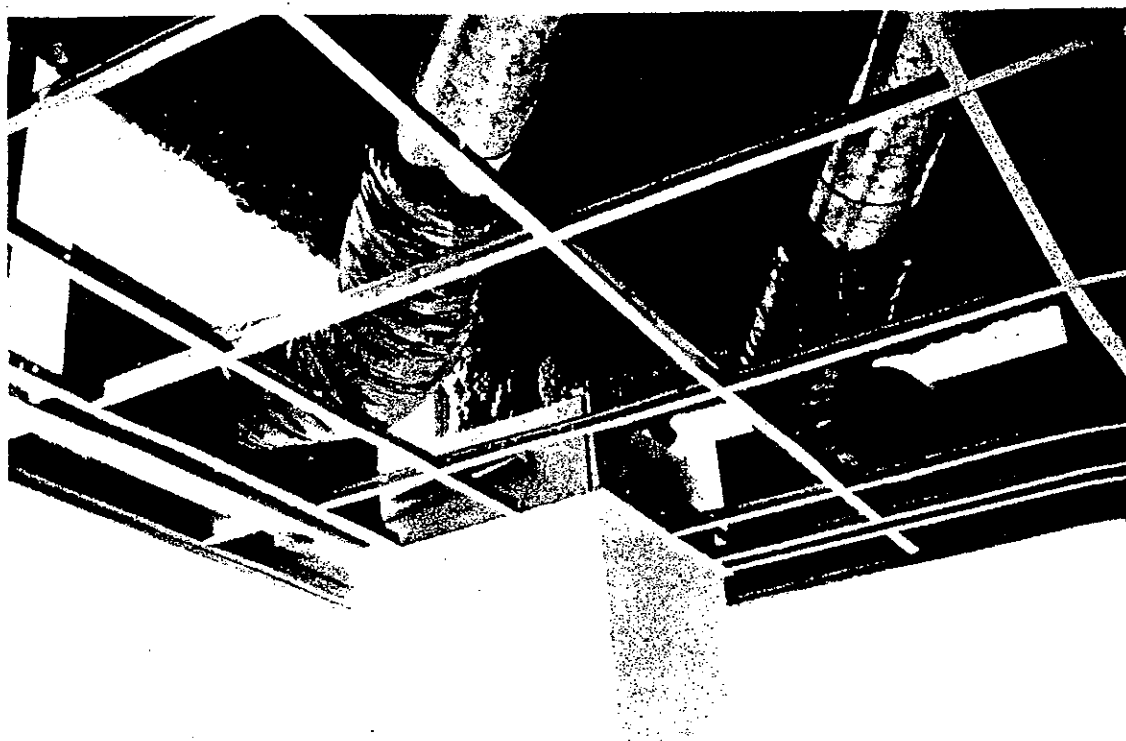
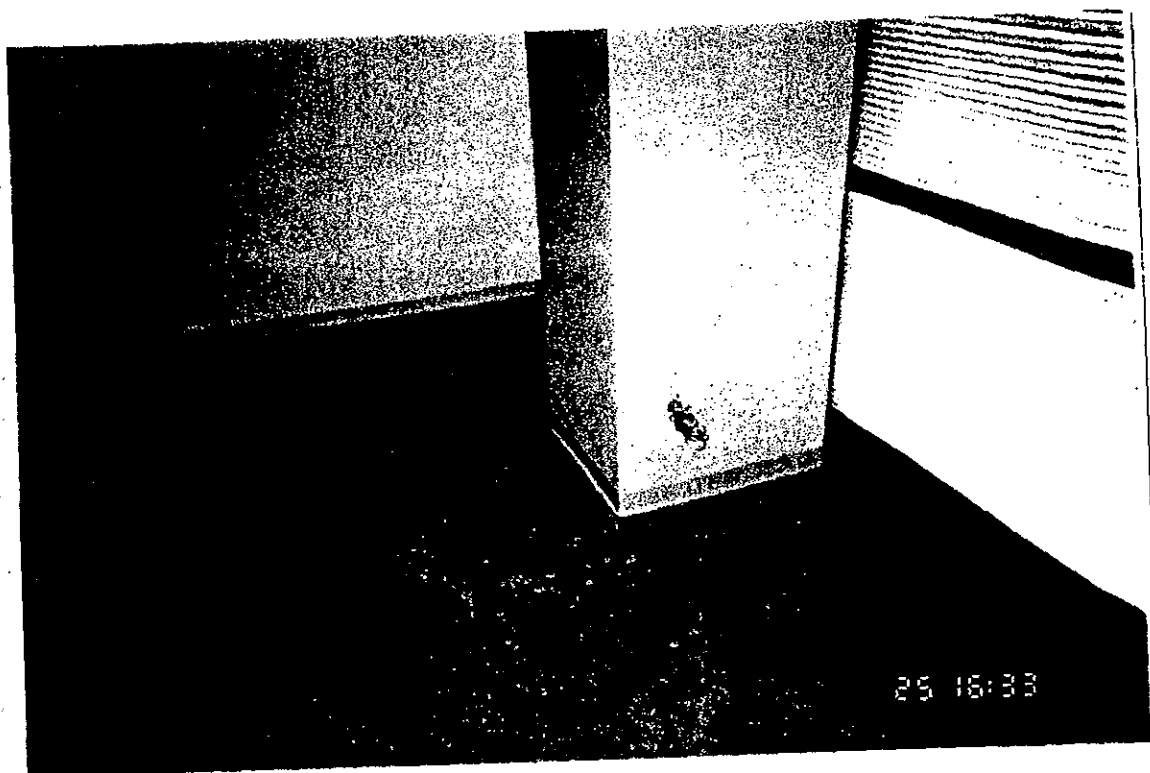
<u>Photograph Number</u>	<u>Photograph Description</u>
25 15:39	Ninth floor, Suite 910, above ceiling, view of re-spray (non-ACM), light fixtures and cables.
25 15:44	Ninth floor, Suite 910, original fireproofing (friable) remaining at hanger attachment point, north duct run.
25 15:45	Ninth floor, Suite 910, original overspray on corrugated deck at south duct run.
25 15:47	Ninth floor, Suite 910, view of beams with re-spray fireproofing.
25 15:53	Ninth floor, Suite 910, view of demising wall and beams with re-spray.
25 15:54	Ninth floor, Suite 910, view of top of column enclosure, northeast corner.
25 16:18	Ninth floor, mechanical room, southwest corner, view of fireproofing debris on floor original and re-spray.
25 16:26	Ninth floor, Suite 950, view of replacement fireproofing above ceiling tile.
25 16:27	Ninth floor, Suite 950, view above ceiling tile of supply air ducts and replacement fireproofing.

25 16:29A	Ninth floor, Suite 950, view below ceiling tile of suite area with cable drops.
25 16:29B	Ninth floor, Suite 950, view below ceiling tile of suite area with cable drops.
25 16:33	Ninth floor, Suite 950, southeast view of column enclosure with utilities.

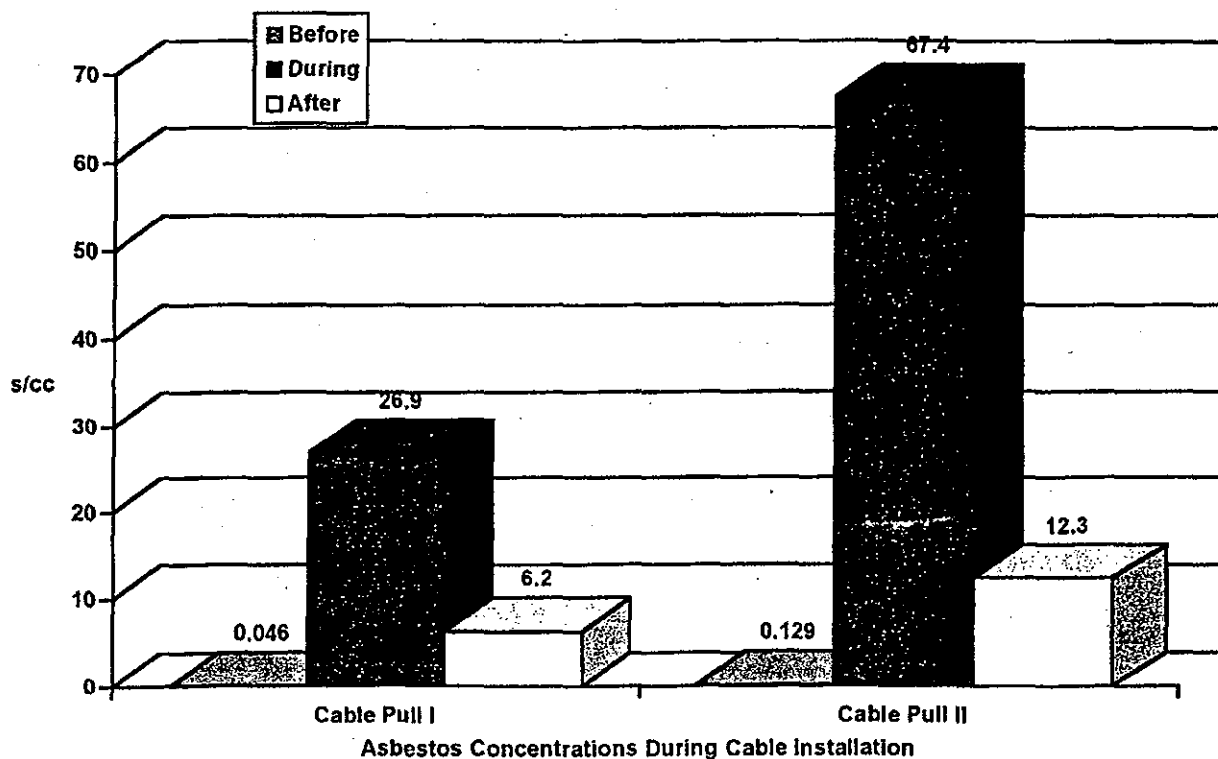
Figure 1. Episodic Exposure Results Before, During and After Installation of Cables in the Vicinity of High Density Fireproofing

DESCRIPTIVE STATISTICS OF ASBESTOS CONCENTRATIONS

Cable Pull I				
Phase	Arithmetic Mean (s/cm ³)	Arithmetic Std. Dev. (s/cm ³)	Geometric Mean	Number of Observations
Before Inst.	0.052	0.030	0.046	5
During Inst.	28.9	12.6	26.9	5
During (Pers.)	10.5	11.6	7.1	3
After Inst.	8.4	7.0	6.2	6

Cable Pull II				
Phase	Arithmetic Mean (s/cm ³)	Arithmetic Std. Dev. (s/cm ³)	Geometric Mean	Number of Observations
Before Inst.	0.158	0.094	0.129	5
During Inst.	100.2	91.9	67.4	4
During (Pers.)	124.8	85.6	102.7	3
After Inst.	17.0	13.5	12.3	4

1 in buildings with spray-applied fireproofing which was the same or substantially similar to
2 the fireproofing in the Prudential Buildings. The results of these studies have been
3 published in peer-reviewed journals and are summarized in Figures 1 - 5.^(87, 89, 90)

4
5 In each of the five studies a particular maintenance, renovation or custodial activity was
6 chosen. Area air sampling was conducted before, during, and after each activity. Personal
7 air samples were also collected on the individuals performing the activities. All samples
8 were analyzed by transmission electron microscopy (TEM) and the personal samples were
9 analyzed by TEM and phase-contrast microscopy (PCM). In each study it was found that
10 the asbestos exposures during the activity increased significantly when compared to
11 concentrations in the air before the activities began. In each instance, the source of the
12 asbestos exposure was the fireproofing, or the dust and debris from the fireproofing.

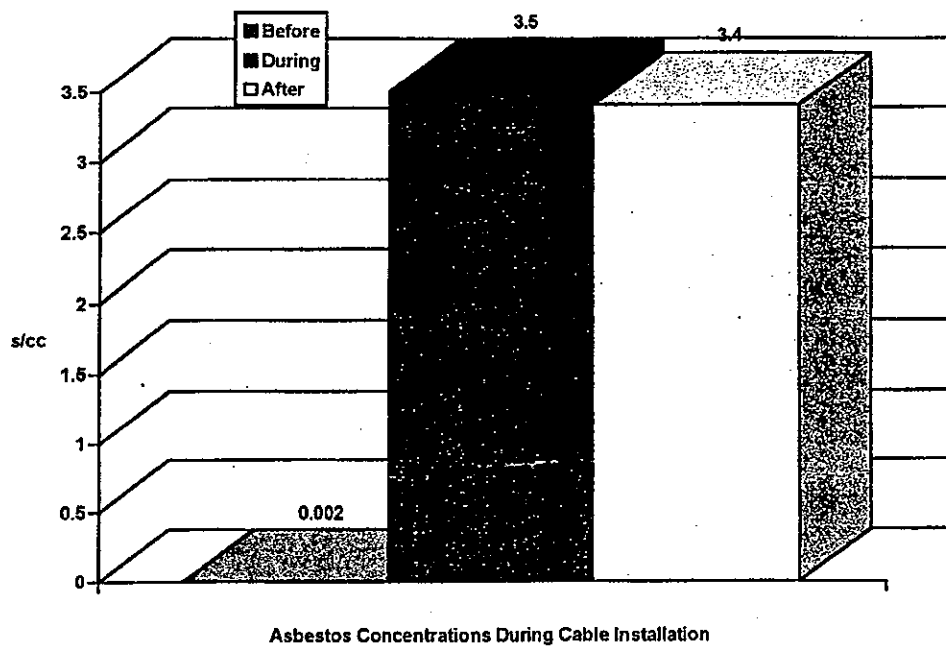
Figure 2. Episodic Exposure Results Before, During and After Installation of Cables in the Vicinity of Low Density Fireproofing

DESCRIPTIVE STATISTICS OF ASBESTOS CONCENTRATIONS

Phase	Arithmetic Mean (s/cm ³)	Arithmetic Std. Dev. (s/cm ³)	Geometric Mean	Number of Observations
Before	0.006	0.014	0.002	5
During (Area)	3.6	0.84	3.5	5
During (Pers.)	26	7.5	26	2
After	3.8	1.9	3.4	5

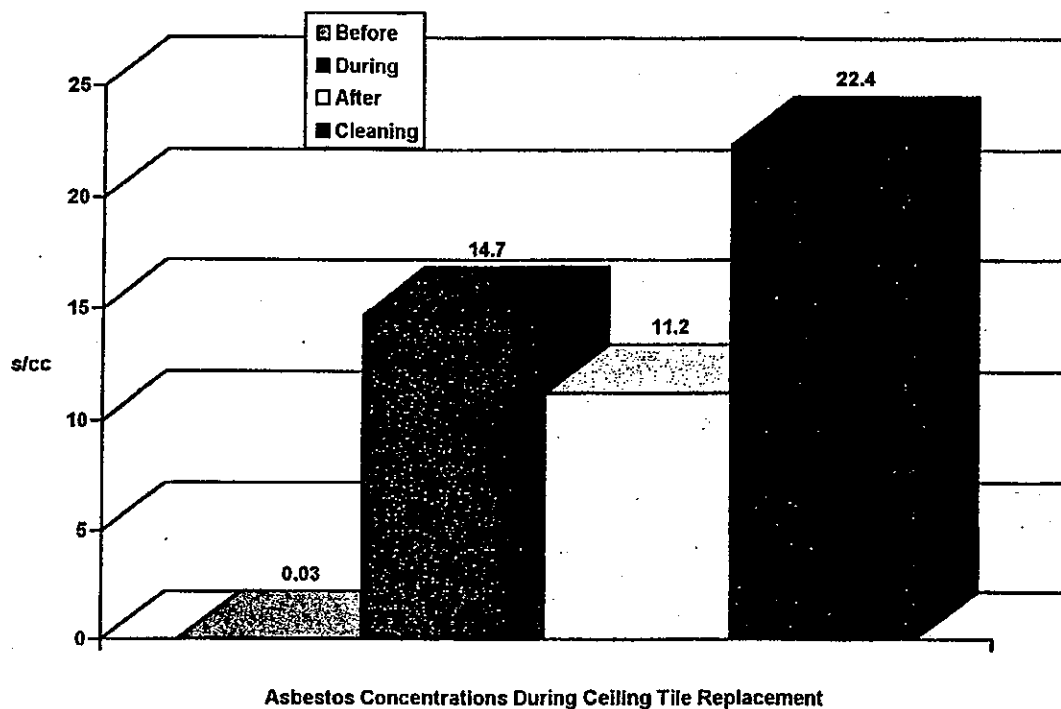
Figure 3. Episodic Exposure Results Before, During, and After Replacement of Ceiling Tiles Below Fireproofing

DESCRIPTIVE STATISTICS OF ASBESTOS CONCENTRATIONS

Phase	Arithmetic Mean (s/cm ³)	Range (s/cm ³)	Geometric Mean (s/cm ³)	Number of Observations
Before	0.05	ND - 0.08	0.03	5
During	15.3	10 - 20	14.7	5
During (Pers.)	23.0	22 - 24	23.0	2
After	11.4	9 - 14	11.2	5
Cleaning	22.4	20 - 24	22.4	5

ND = No Asbestos Structures Detected

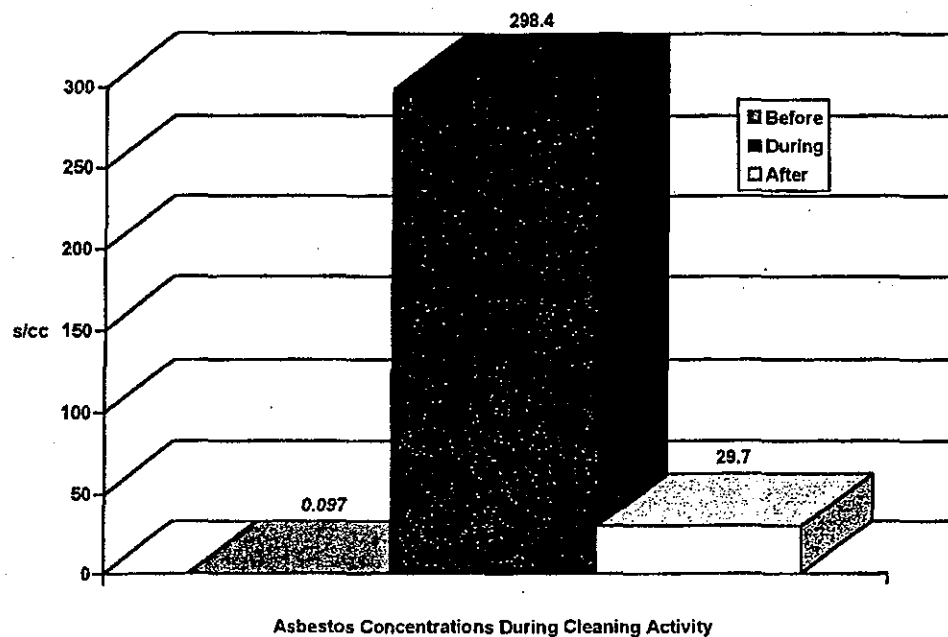
Figure 4. Episodic Exposure Results Before, During and After Cleaning a Storage Room in a Building with Fireproofing

DESCRIPTIVE STATISTICS OF ASBESTOS CONCENTRATIONS

Phase	Arithmetic Mean (s/cm ³)	Arithmetic Std. Dev. (s/cm ³)	Geometric Mean	Number of Observations
Before - Inside	0.264	0.221	0.097	5
During - Inside	329.9	173.0	298.4	5
During - Inside (Personal)	343.8	360.6	237.1	3
After - Inside	31.8	12.3	29.7	5

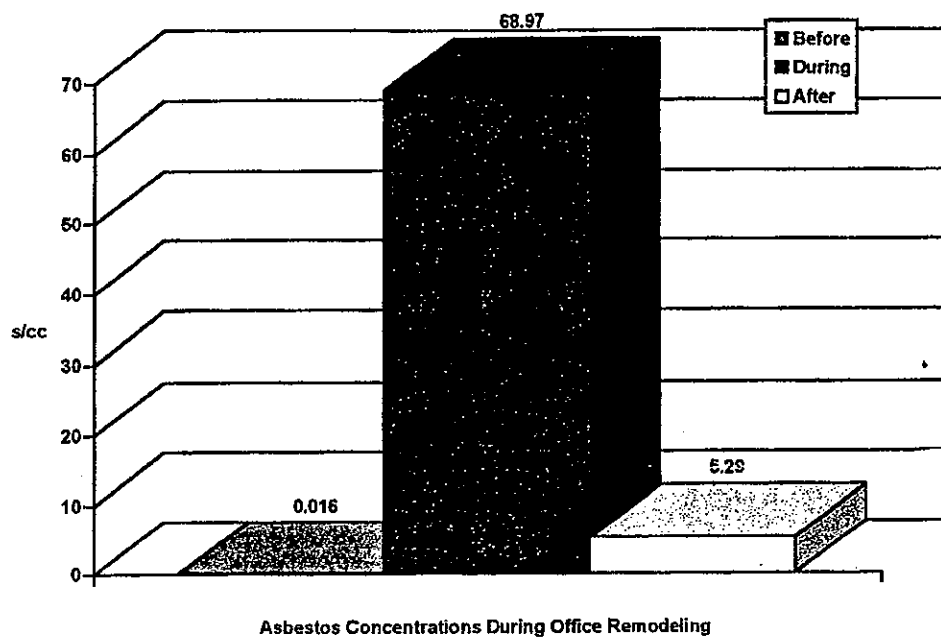
DESCRIPTIVE STATISTICS OF ASBESTOS CONCENTRATIONS

Phase	Arithmetic Mean (s/cm ³)	Arithmetic Std. Dev. (s/cm ³)	Geometric Mean	Number of Observations
Before	0.045	0.048	0.016	5
During (Area)	73.32	27.08	68.97	6
During (Pers.)	150.79	164.68	71.60	4
After	5.81	2.39	5.29	4

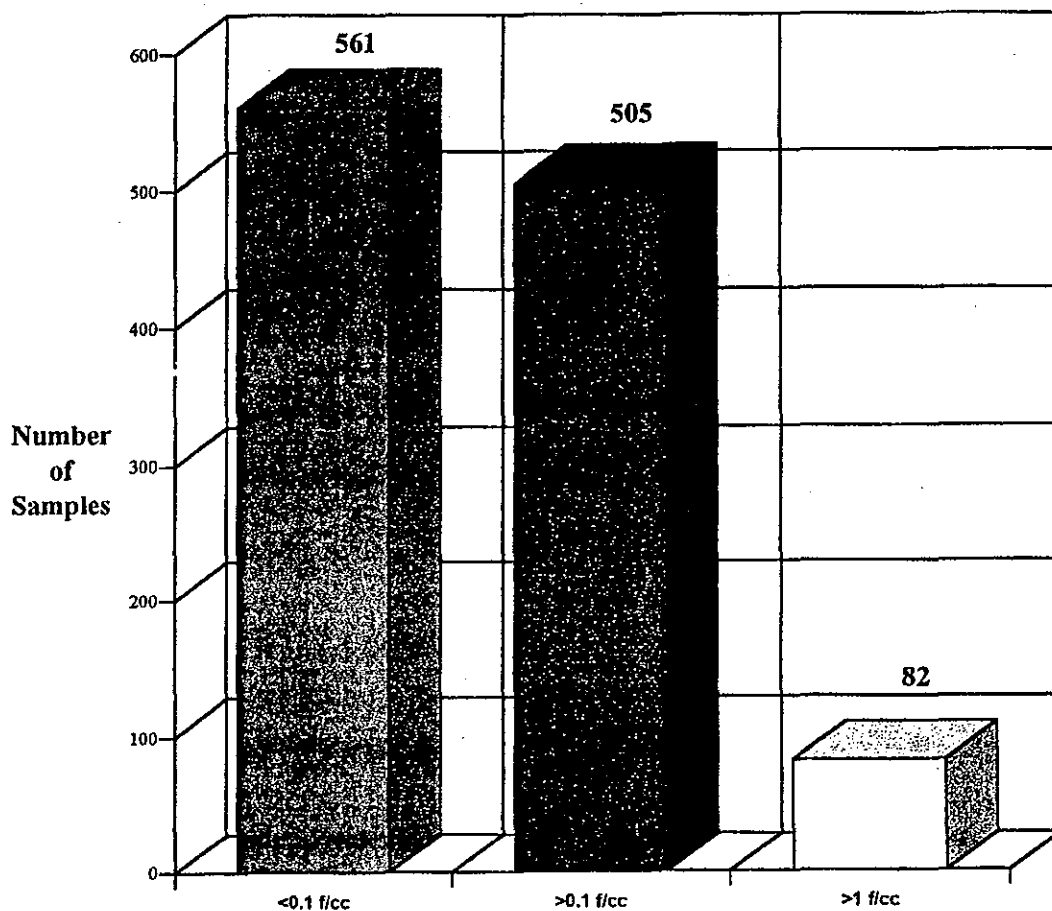
Figure 6. Distribution of Fiber Concentrations Measured on Persons Performing Maintenance and Renovation Activities in Prudential Buildings (1066 samples)

17
18 A total of 1097 samples (1066 personal samples, 31 area samples) are included in the data
19 set. Of these, 22 samples are reported as overloaded and 3 samples were reported voided.
20
21 Of the 1066 personal samples, 505 (47%) were greater than or equal to 0.1 f/cc and 82
22 (8%) were greater than 1 f/cc. These results are depicted in Figure 6. These results are

1 consistent with results reported in the published literature and further demonstrate that
2 maintenance and renovation activities in buildings with spray-applied friable fireproofing
3 routinely cause elevated airborne exposures.
